Summary of SGC Manufactured Home Field Data (1997-98 Sitings in Idaho and Washington)

**Prepared for the Idaho Department of
Water Resources – Energy Division
Ken Eklund, Project Manager**

Introduction

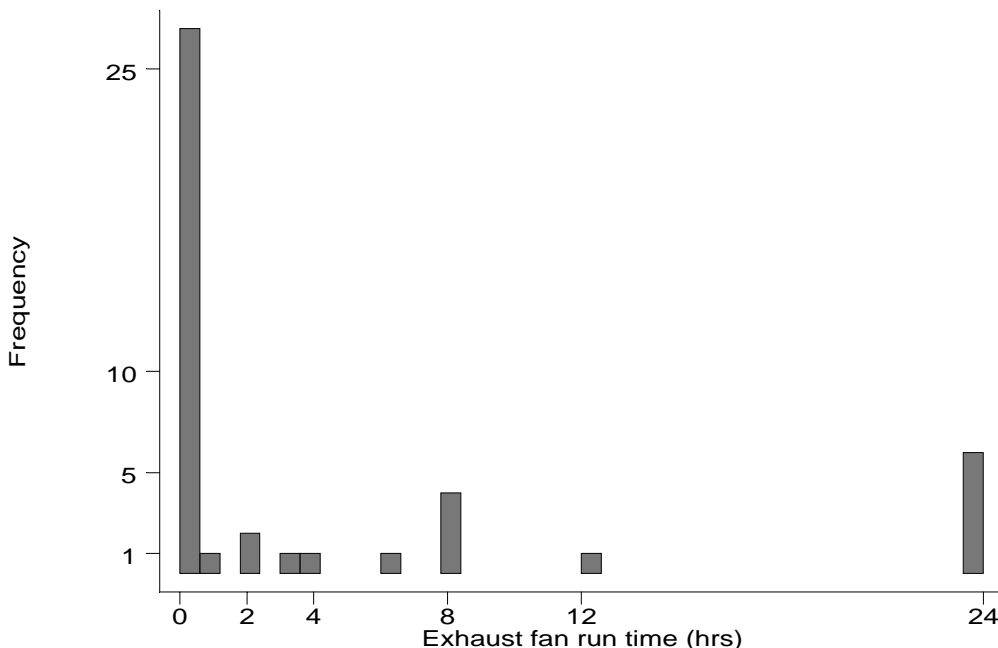
Limited run time is really the issue here. Even a 40 CFM fan can provide effective ventilation if it is run continuously. As the chart below shows, 63% of the fans not controlled by an automatic timer (26/41 cases) were turned off at the time of the audit. In most of these cases, this was the normal operating condition of the fan as ascertained by the auditor. Only 27% of the homes had whole house fans controlled by an operating timer or dedicated circuit breaker.

A fan moving 70 CFM has to run about 20 hours/day to augment natural ventilation of 0.20 ACH sufficiently to reach the ASHRAE-recommended level of 0.35 ACH. There are only 3 cases in our set of homes where the fan was run at this level and only 8 homes where the fan was controlled to operate for 8 hours/day or more. In three of these cases, whole house fan operation was controlled by the Northwest Timer Kit.

Lessons are clear: (#1) Homeowners need to be educated (once again) about the importance of ventilation (especially as homes get tighter), controls need to be labeled (and placed so that the homeowner notices them), and fans need to be operated. Homes are still leaky enough to provide plenty of air to these fans, but if they are never turned on, the average ventilation rate of many of the homes is quite likely to fall well below ASHRAE-recommended levels. (#2) Manufacturers must install fans properly and in-plant inspection and quality assurance need to ensure this.
